**FACILITY ASSESSMENT REPORT
MAPLE VALLEY SCHOOL DISTRICT
TOWER CITY SCHOOL**

APRIL 2016

ICON
ARCHITECTURAL GROUP

FACILITY SUMMARY

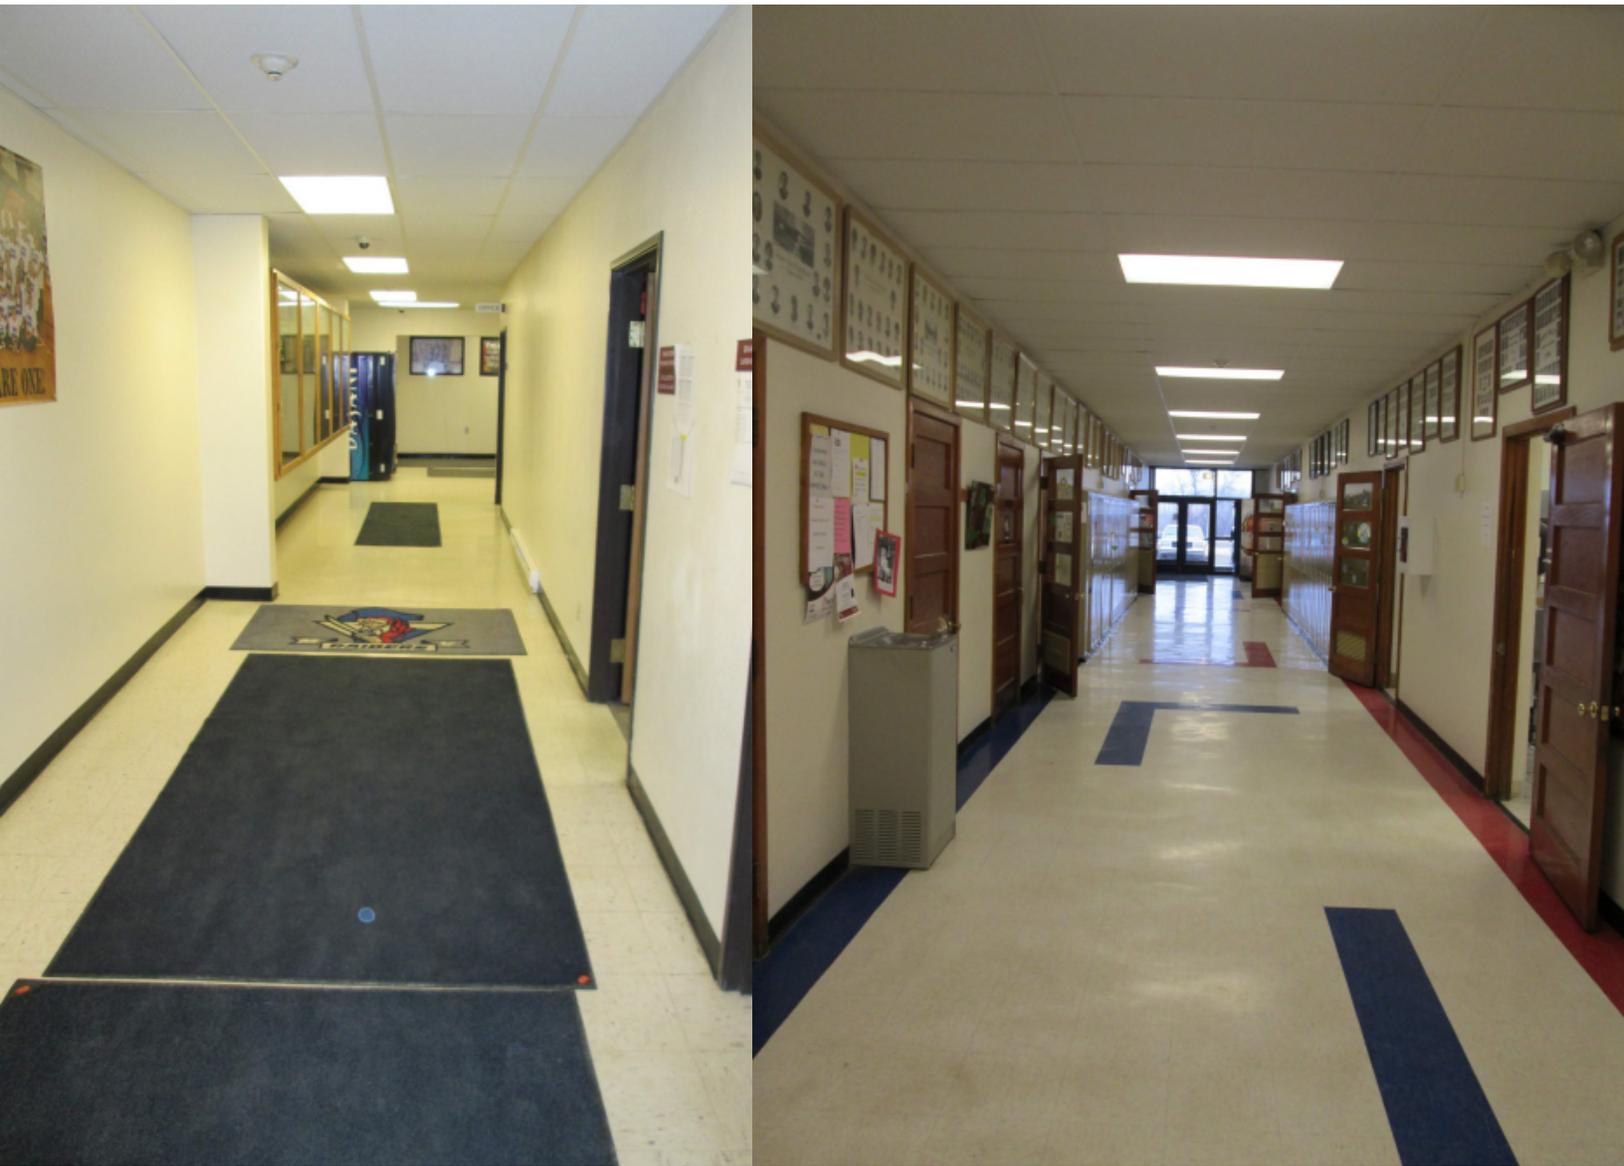
2012 IBC: SECTION 903.2.3 GROUP E

- An automatic sprinkler system shall be provided for Group E occupancies as follows:
 - Throughout all Group E fire areas greater than 12,000 square feet in area.

Corrective Action: Provide automatic sprinkler system throughout existing building.

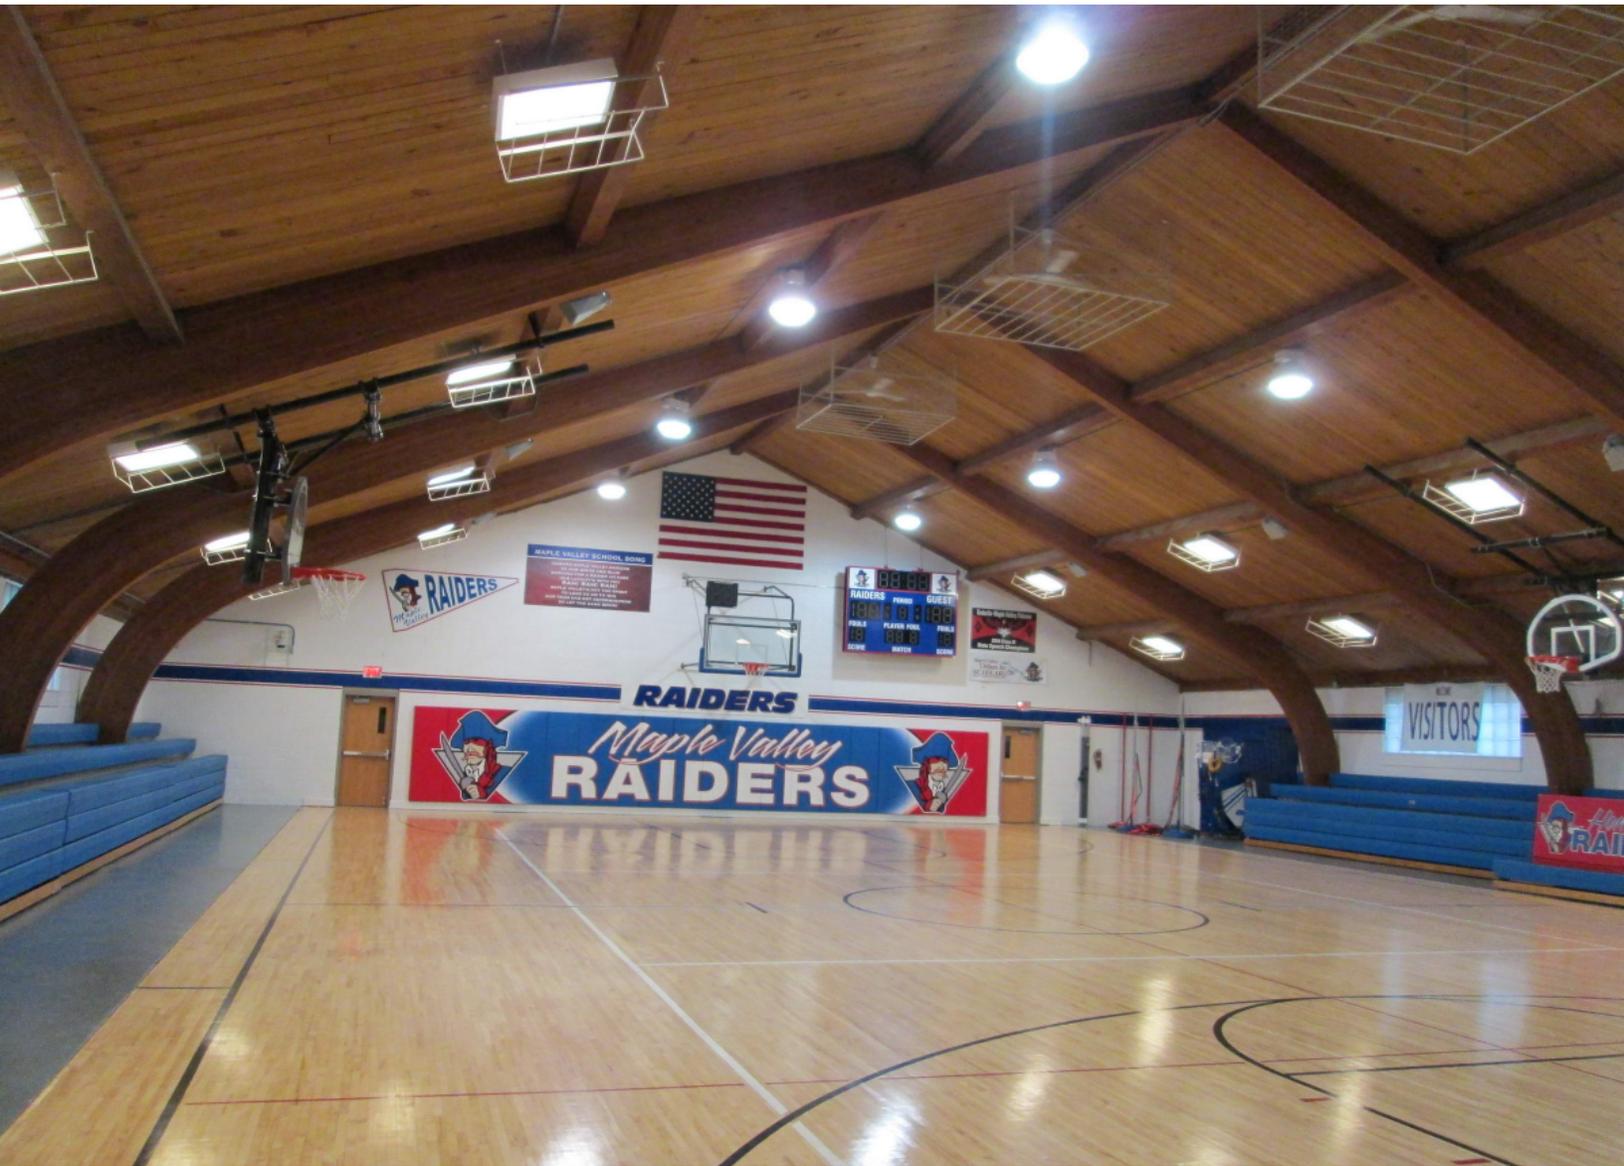
2012 IBC: SECTION 903.2.3 GROUP E

- An automatic sprinkler system shall be provided for Group E occupancies as follows:
 - Throughout all Group E fire areas greater than 12,000 square feet in area.

Corrective Action: Provide automatic sprinkler system throughout existing building. Provide smoke detection in gymnasium. Replace light fixtures with energy efficient fixtures.

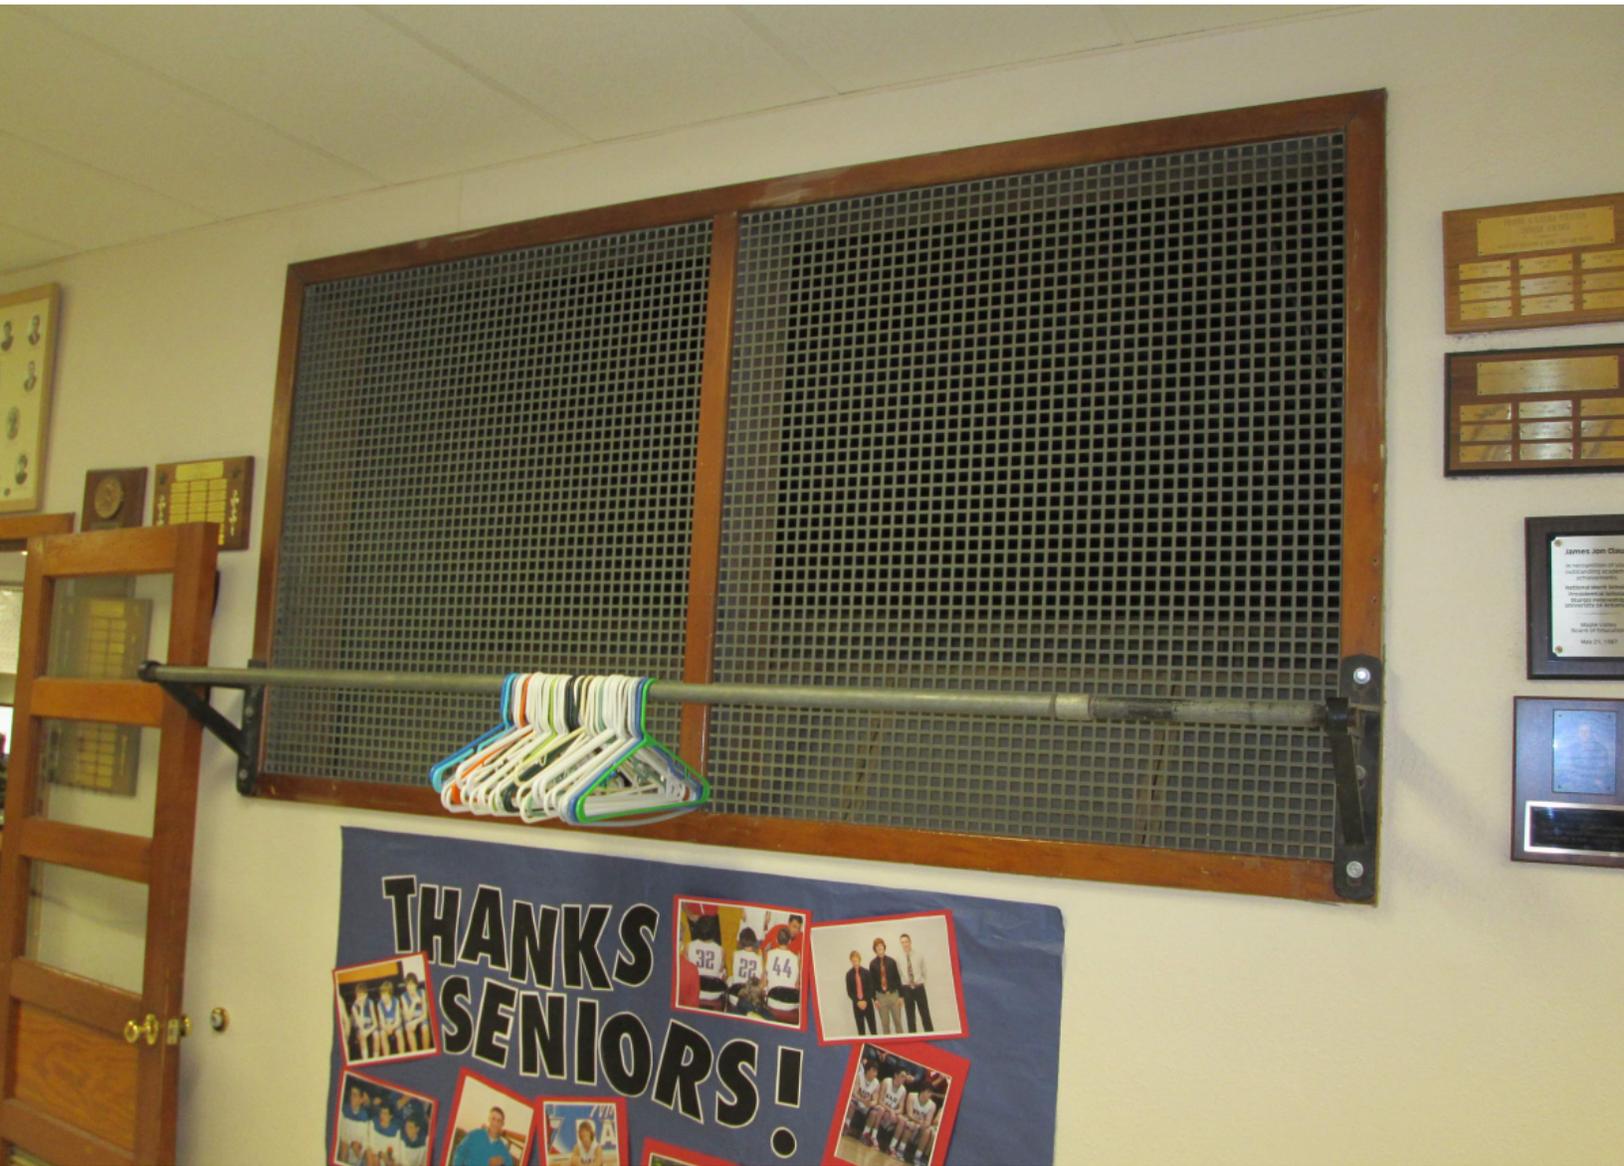
In 1952, the original building was constructed and is heated with the original coal fired furnace that was converted over to natural gas. The gas burner is a Gordon-Piatt burner that was installed in 2002. Gordon-Piatt went out of business in 2009. The supply air is distributed via tunnels to floor grilles into each classroom. The return air is transferred through door grilles to the corridor and returned back to the furnace through a common return grille in the corridor wall. The existing HVAC system for this portion of the building does not meet current ventilation and energy codes. Replacing the existing ventilation system would be recommended for this portion of the building.

Corrective Action: The supply air is distributed via tunnels to floor grilles into each classroom. The return air is transferred through door grilles to the corridor and returned back to the furnace through a common return grille in the corridor wall. The existing HVAC system for this portion of the building does not meet current ventilation and energy codes. Replacing the existing ventilation system would be recommended for this portion of the building.

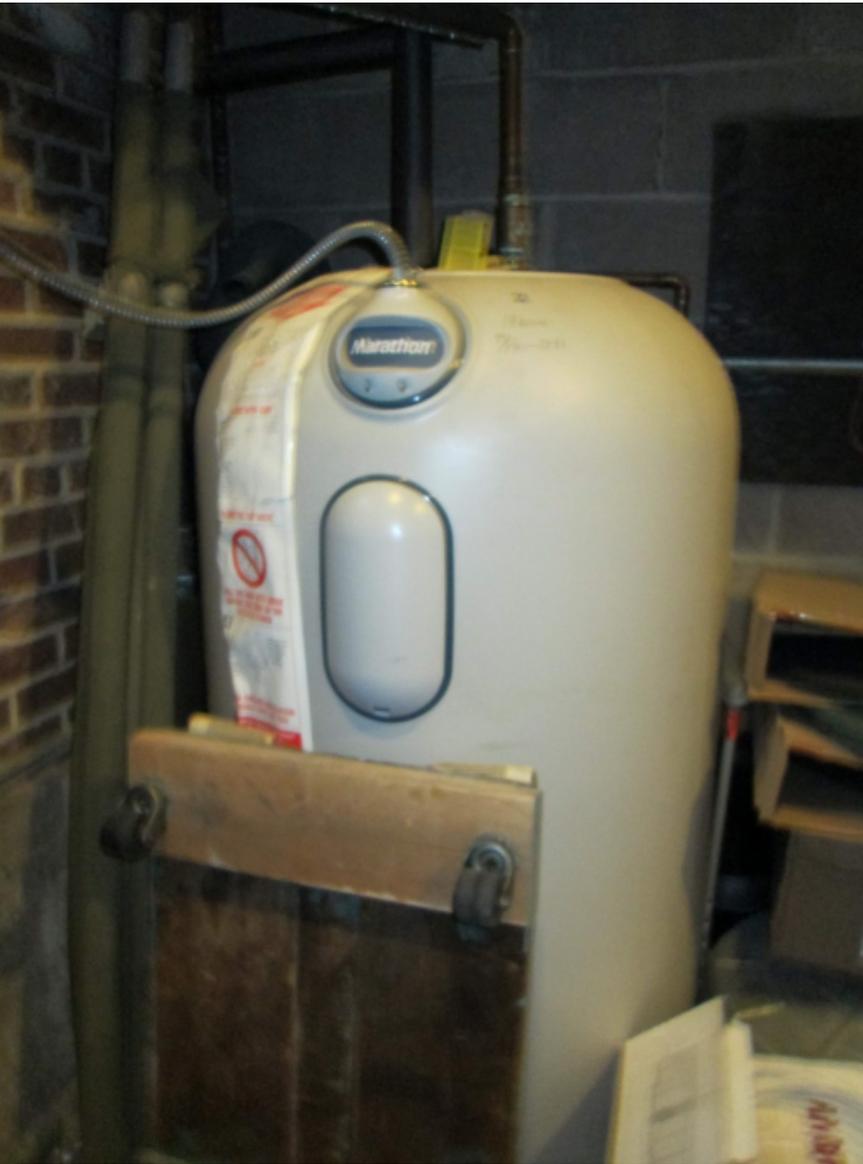
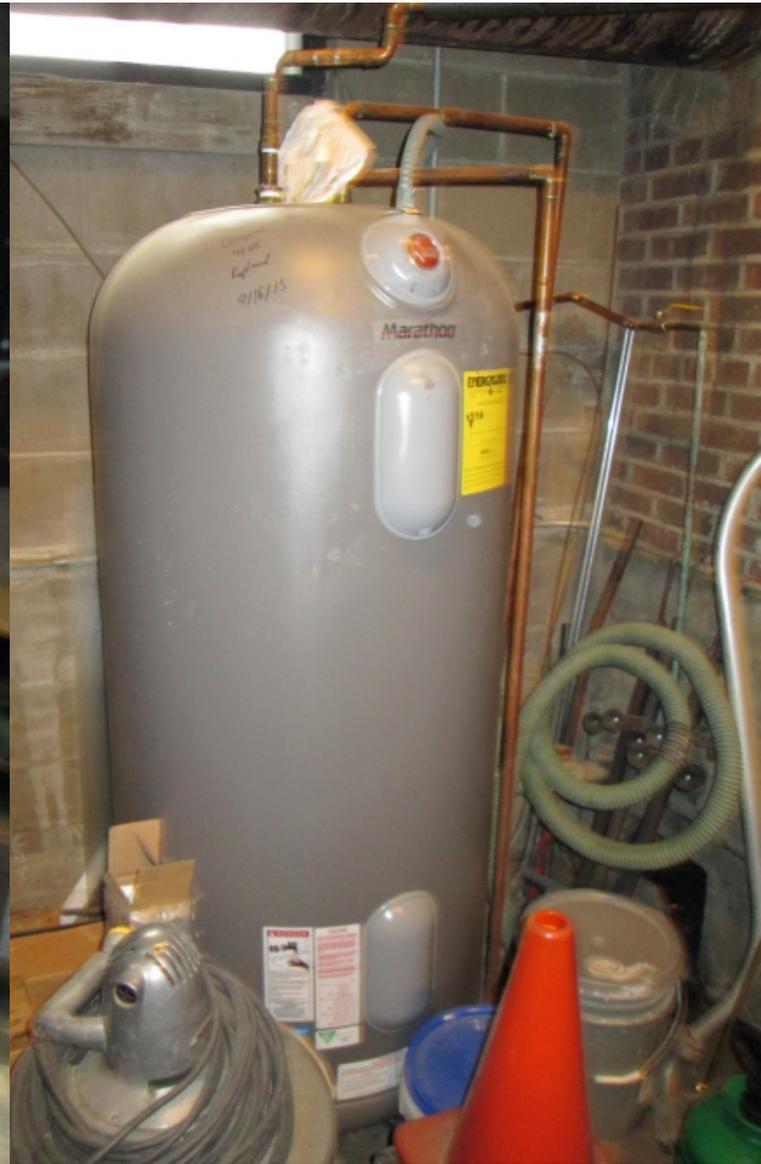
There are two electric water heaters that serve the original 1952 building. One electric water heater was installed in 2001 and it approaching the end of its useful life. The other was installed in 2013 and could be reused. There was also a new high-efficiency, gas-fired water heater added for the locker room in 2013 and could be reused.

Corrective Action: There are two electric water heaters that serve the original 1952 building. One electric water heater was installed in 2001 and it approaching the end of its useful life. The other was installed in 2013 and could be reused. There was also a new high-efficiency, gas-fired water heater added for the locker room in 2013 and could be reused.

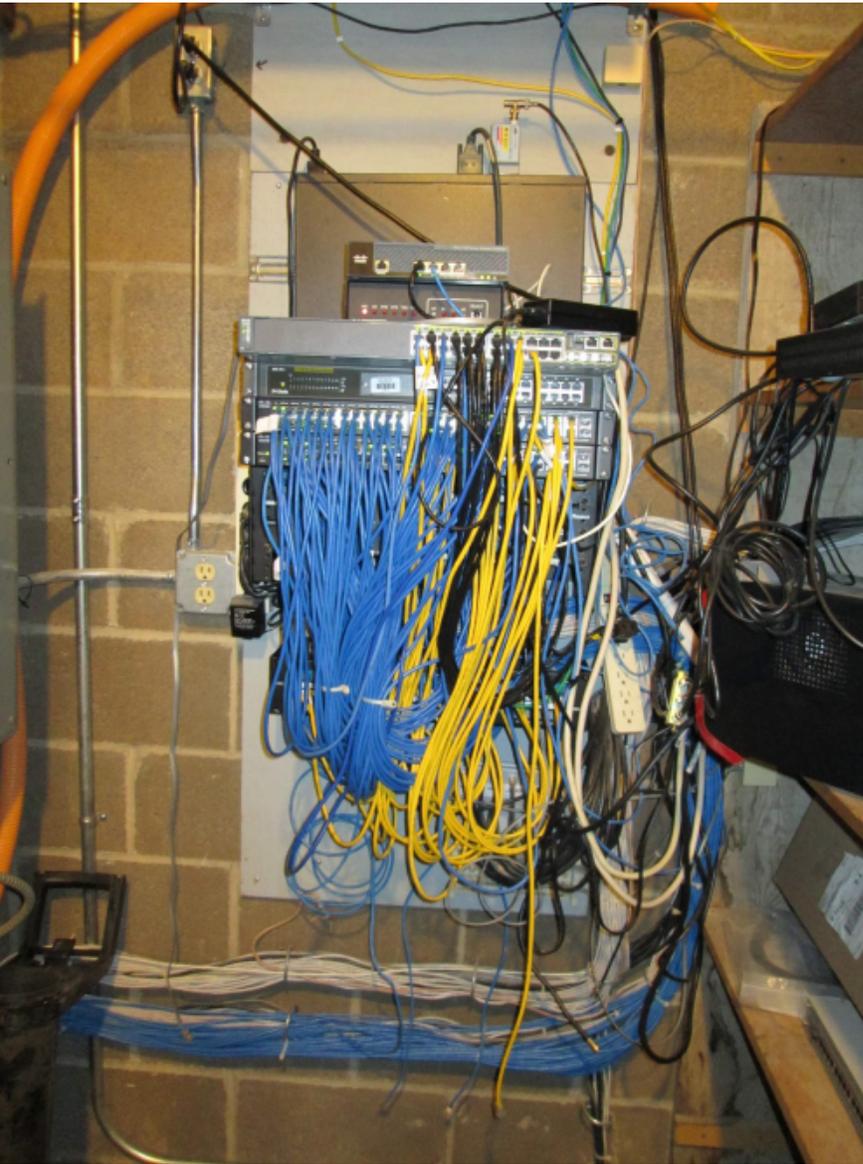
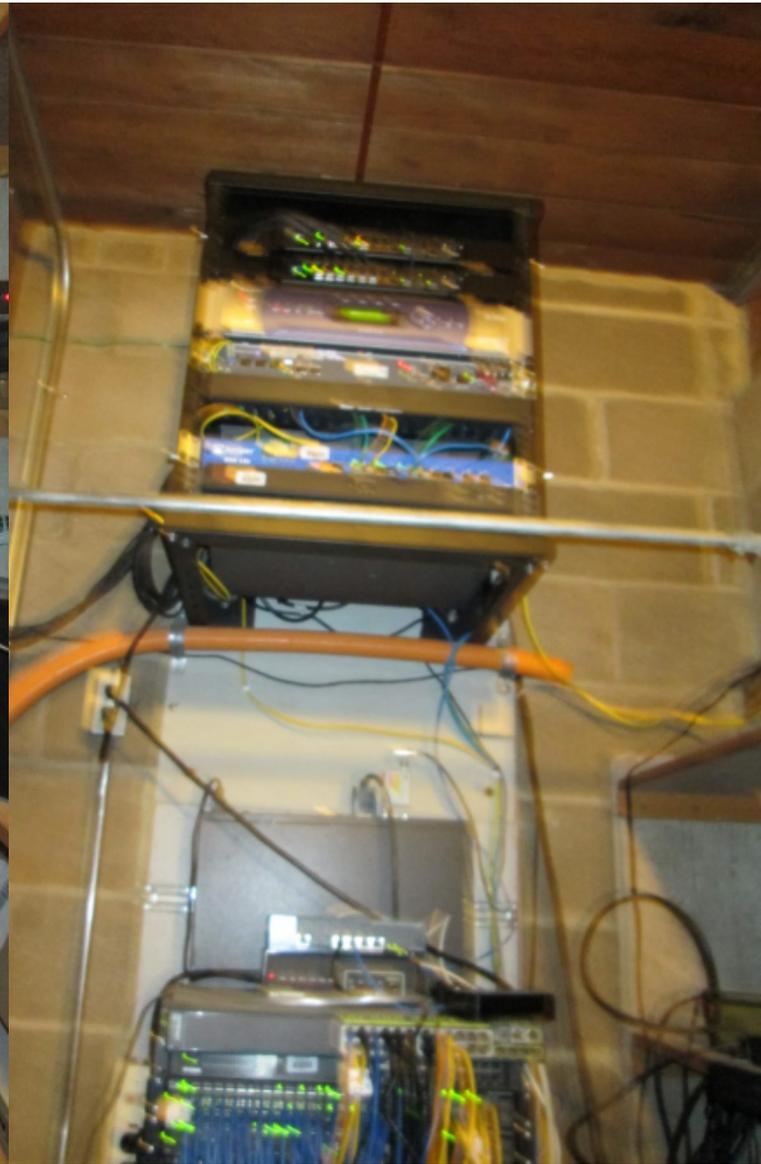
Data equipment is stored in the mechanical room and is not properly temperature controlled. Auxiliary cooling unit would need to be added and equipment should be relocated to another dedicated data room space.

Corrective Action: Data equipment is stored in the mechanical room and is not properly temperature controlled. Auxiliary cooling unit would need to be added and equipment should be relocated to another dedicated data room space.

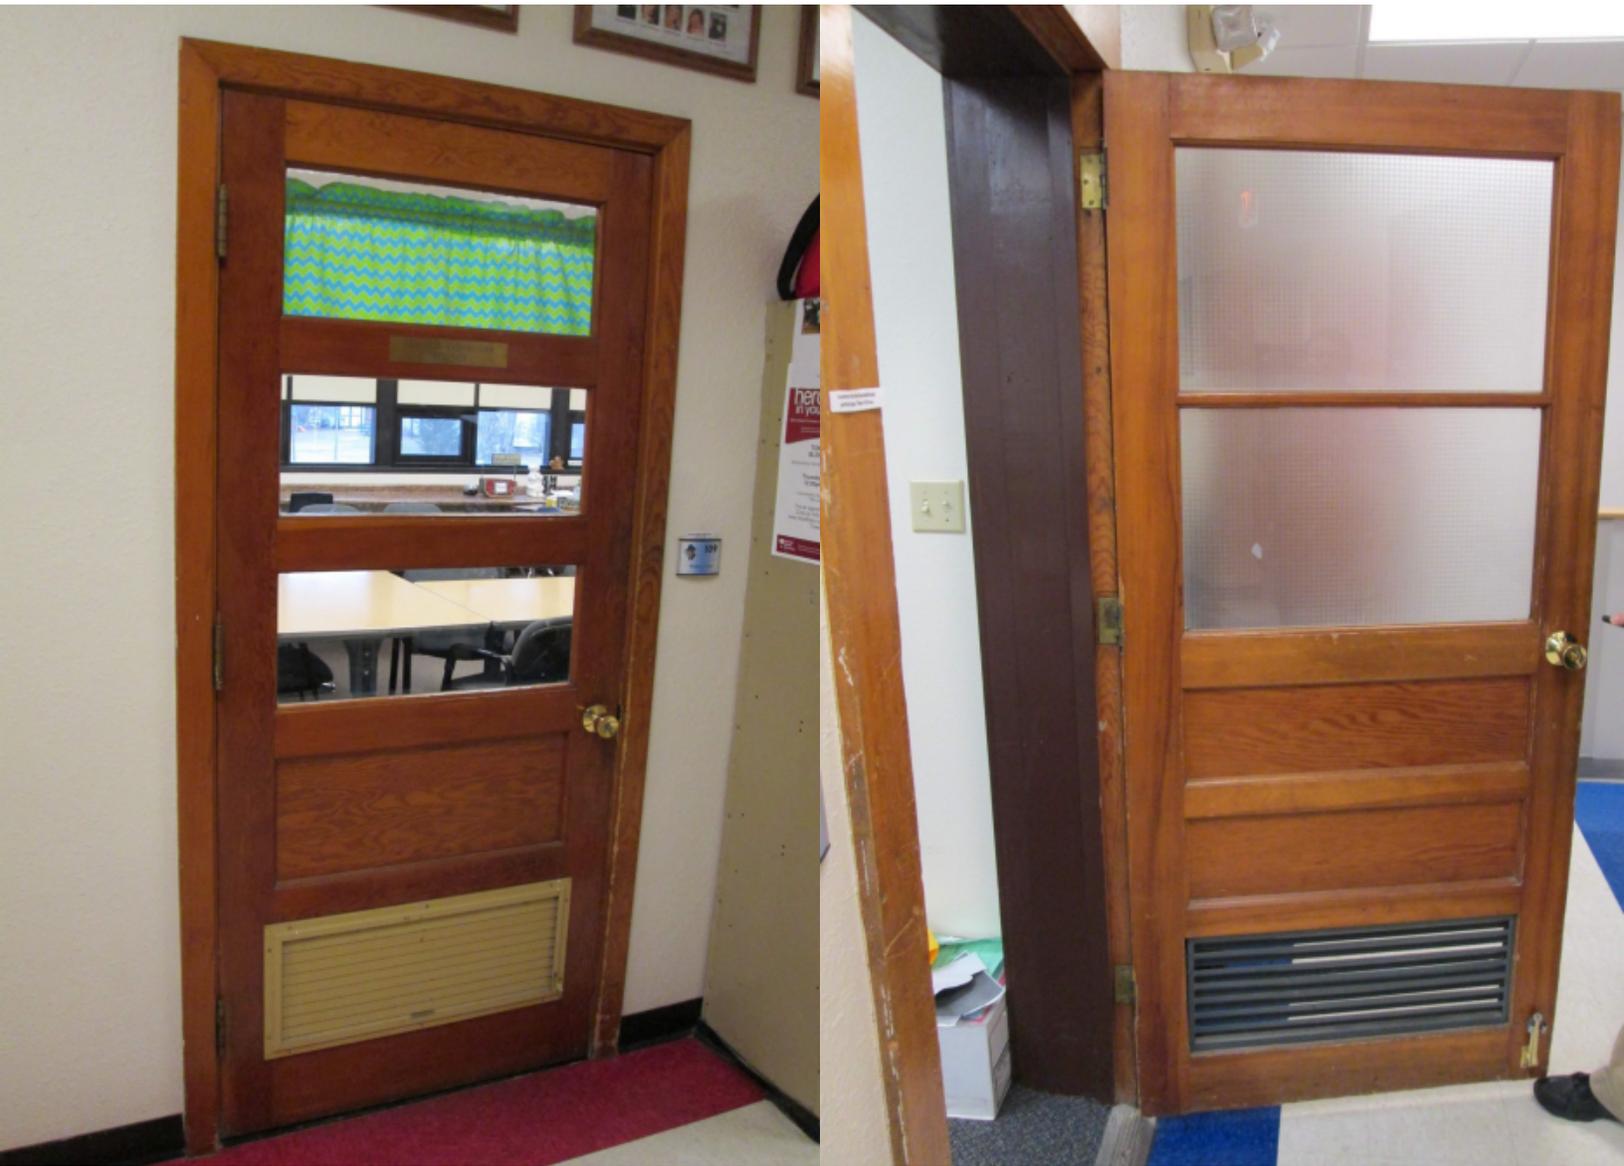
2012 IBC: SECTION 716.5.3 DOOR ASSEMBLIES IN CORRIDORS AND SMOKE BARRIERS

- Fire door assemblies required to have a minimum fire protection rating of 20 minutes where located in corridor walls or smoke barrier walls

2012 IBC: SECTION 1008.1.9.1 HARDWARE

- Door handles, pulls, latches, locks and other operating devices on doors required to be accessible by Chapter 11 shall not require tight grasping, tight pinching or twisting of the wrist to operate.

Corrective Action: Replace all doors and frames in corridors with properly fire-rated doors and frames including fire-rated glass and louvers. Replace all door hardware with accessible hardware.

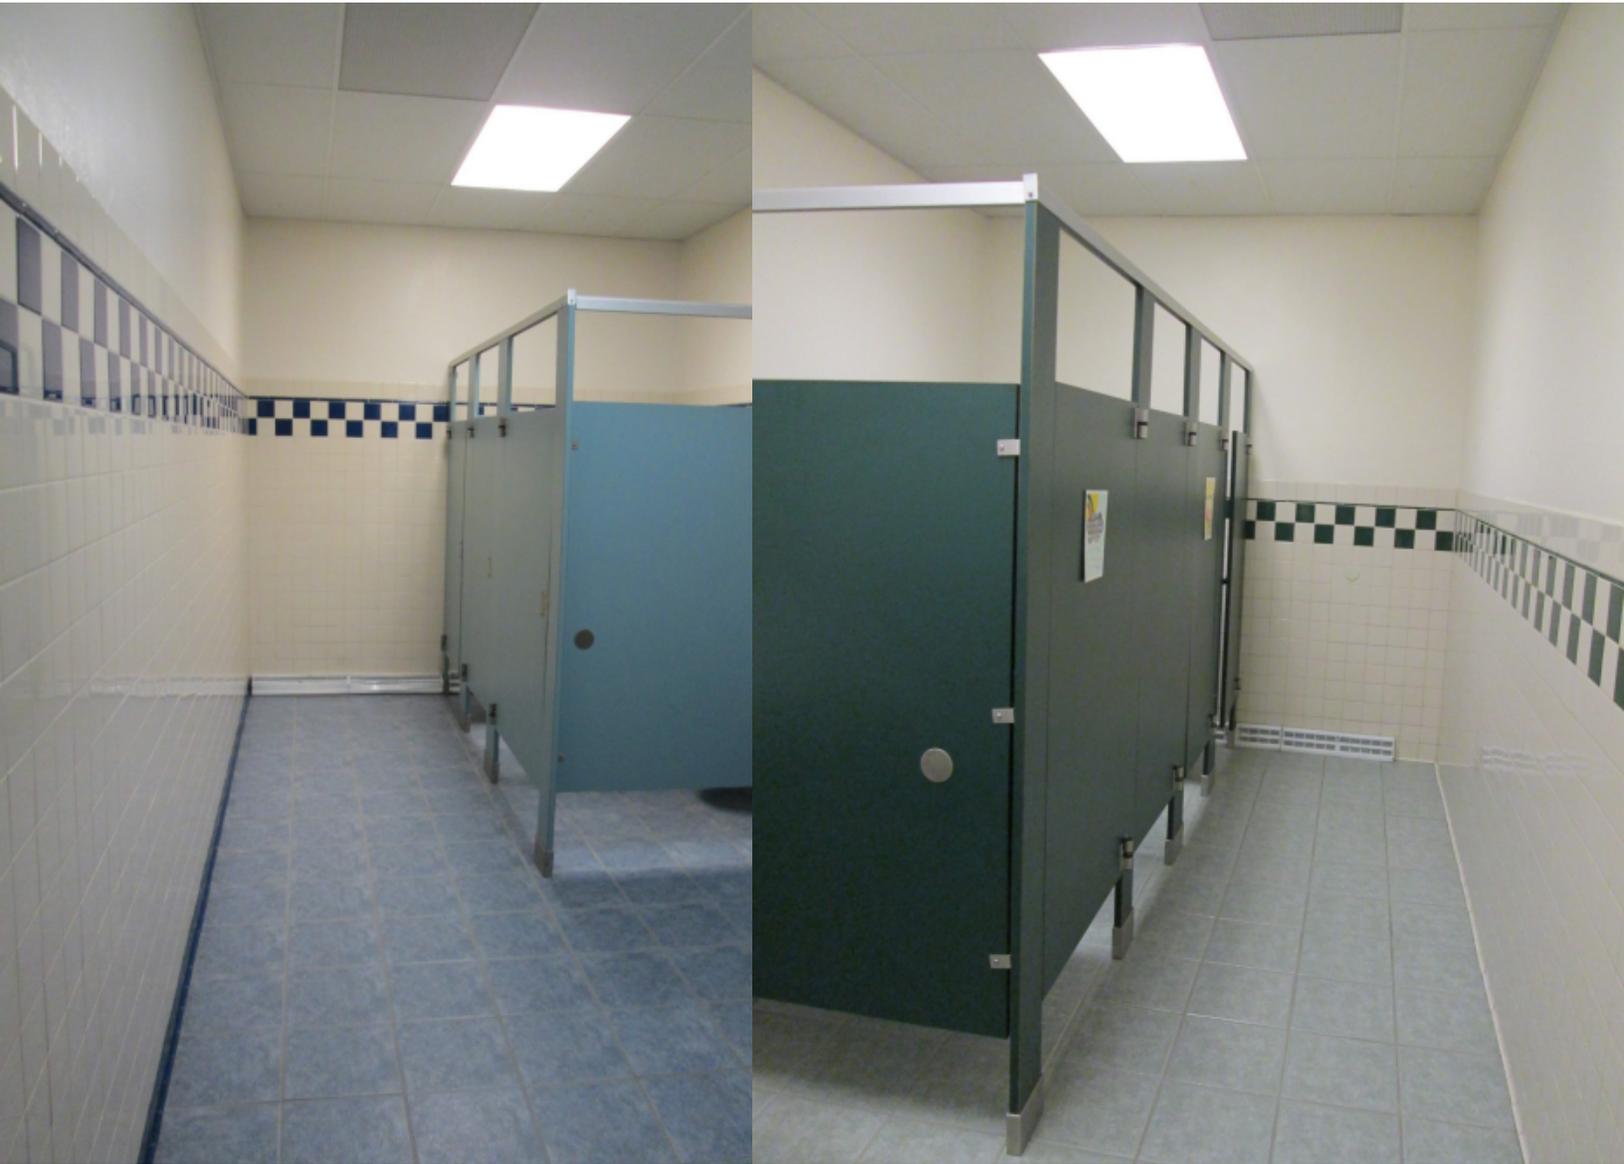
The bathrooms in the original 1952 building appeared to have been remodeled, but they do not meet current ADA requirements and would need to be reconfigured, which would include reinstalling the existing plumbing fixtures at the required ADA heights.

2012 IBC: SECTION 1109.2 TOILET AND BATHING FACILITIES

- Each toilet room and bathing room shall be accessible. At least one of each type of fixture, element, control or dispenser in each accessible toilet room and bathing room shall be accessible.

Corrective Action: Provide accessible restrooms and add fixtures to meet required plumbing counts.

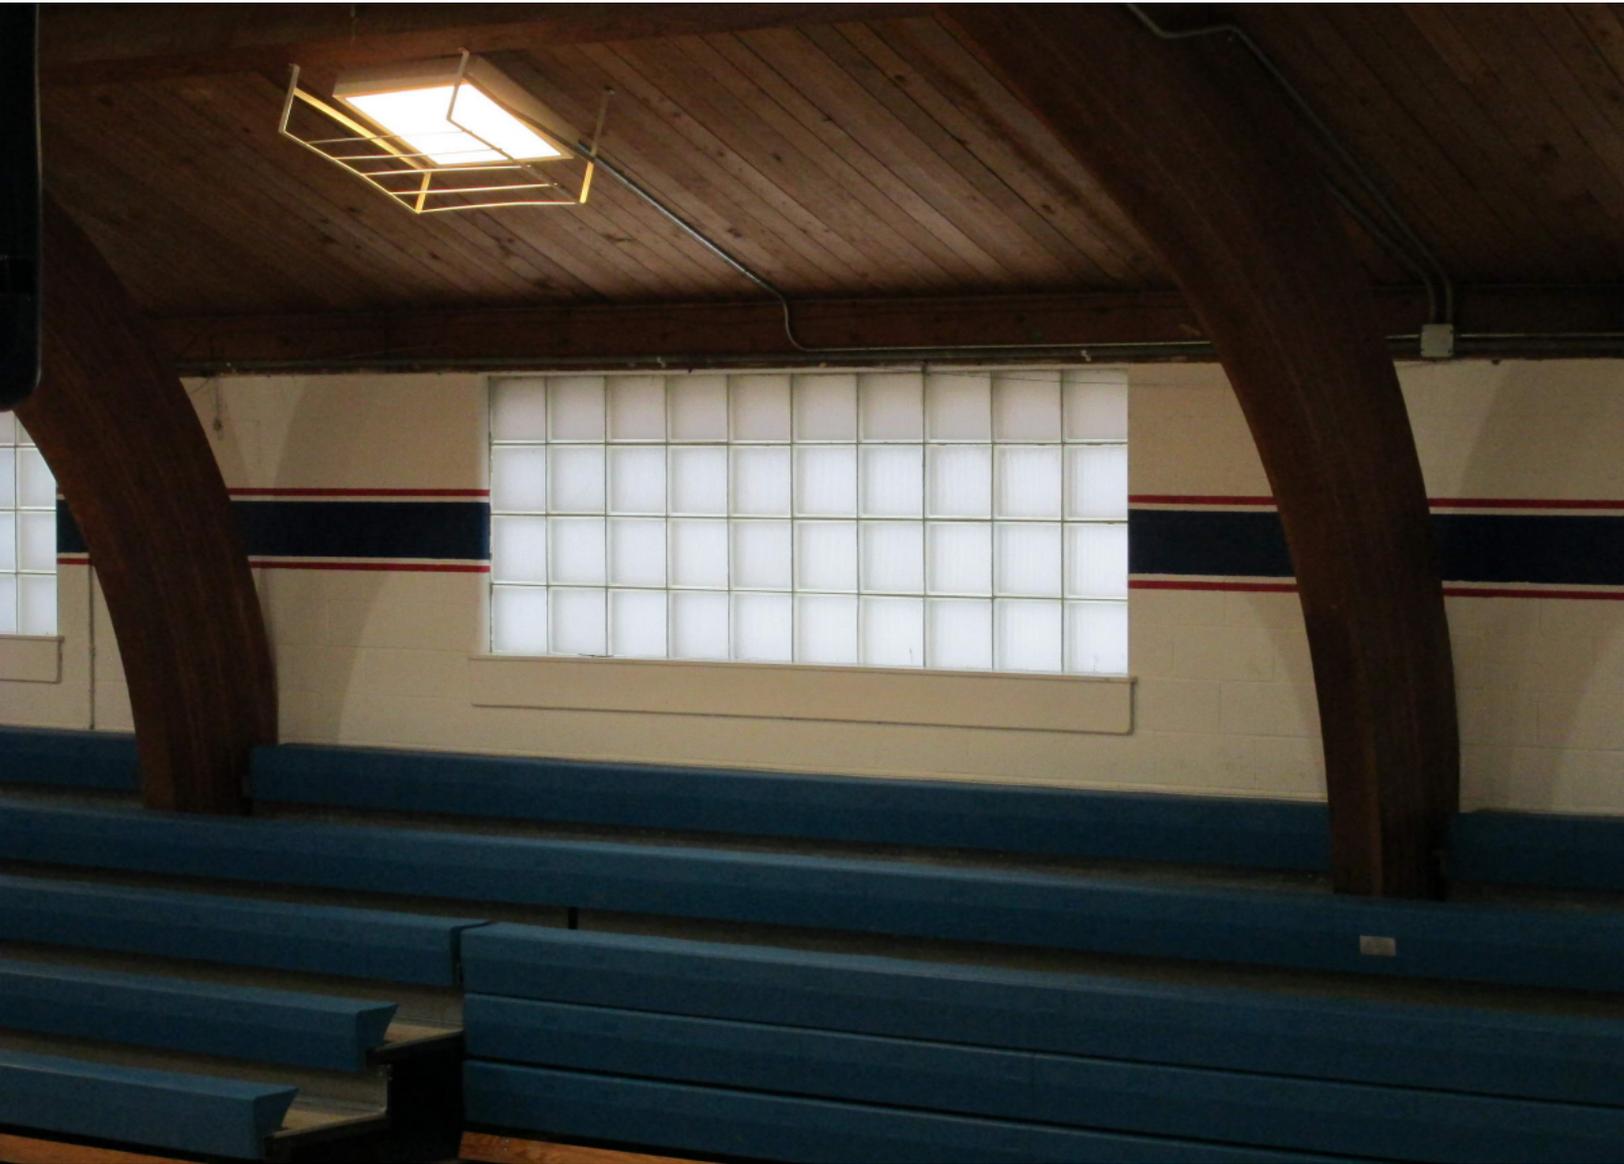
The original building is concrete masonry walls with a wood roof structure. The gymnasium is concrete masonry exterior walls, three-point hinged laminated arches and wood ceiling. There is very little to no insulation in the gymnasium, making it inefficient and difficult to climate control. The addition, built in 2013, is concrete masonry walls with a steel post and beam structure. New storefront and windows have been installed throughout the building along with interior finish renovations.

Corrective Action: Exterior walls, roof and windows of gymnasium provide poor insulation and should be corrected to provide a comfortable and efficient environment.

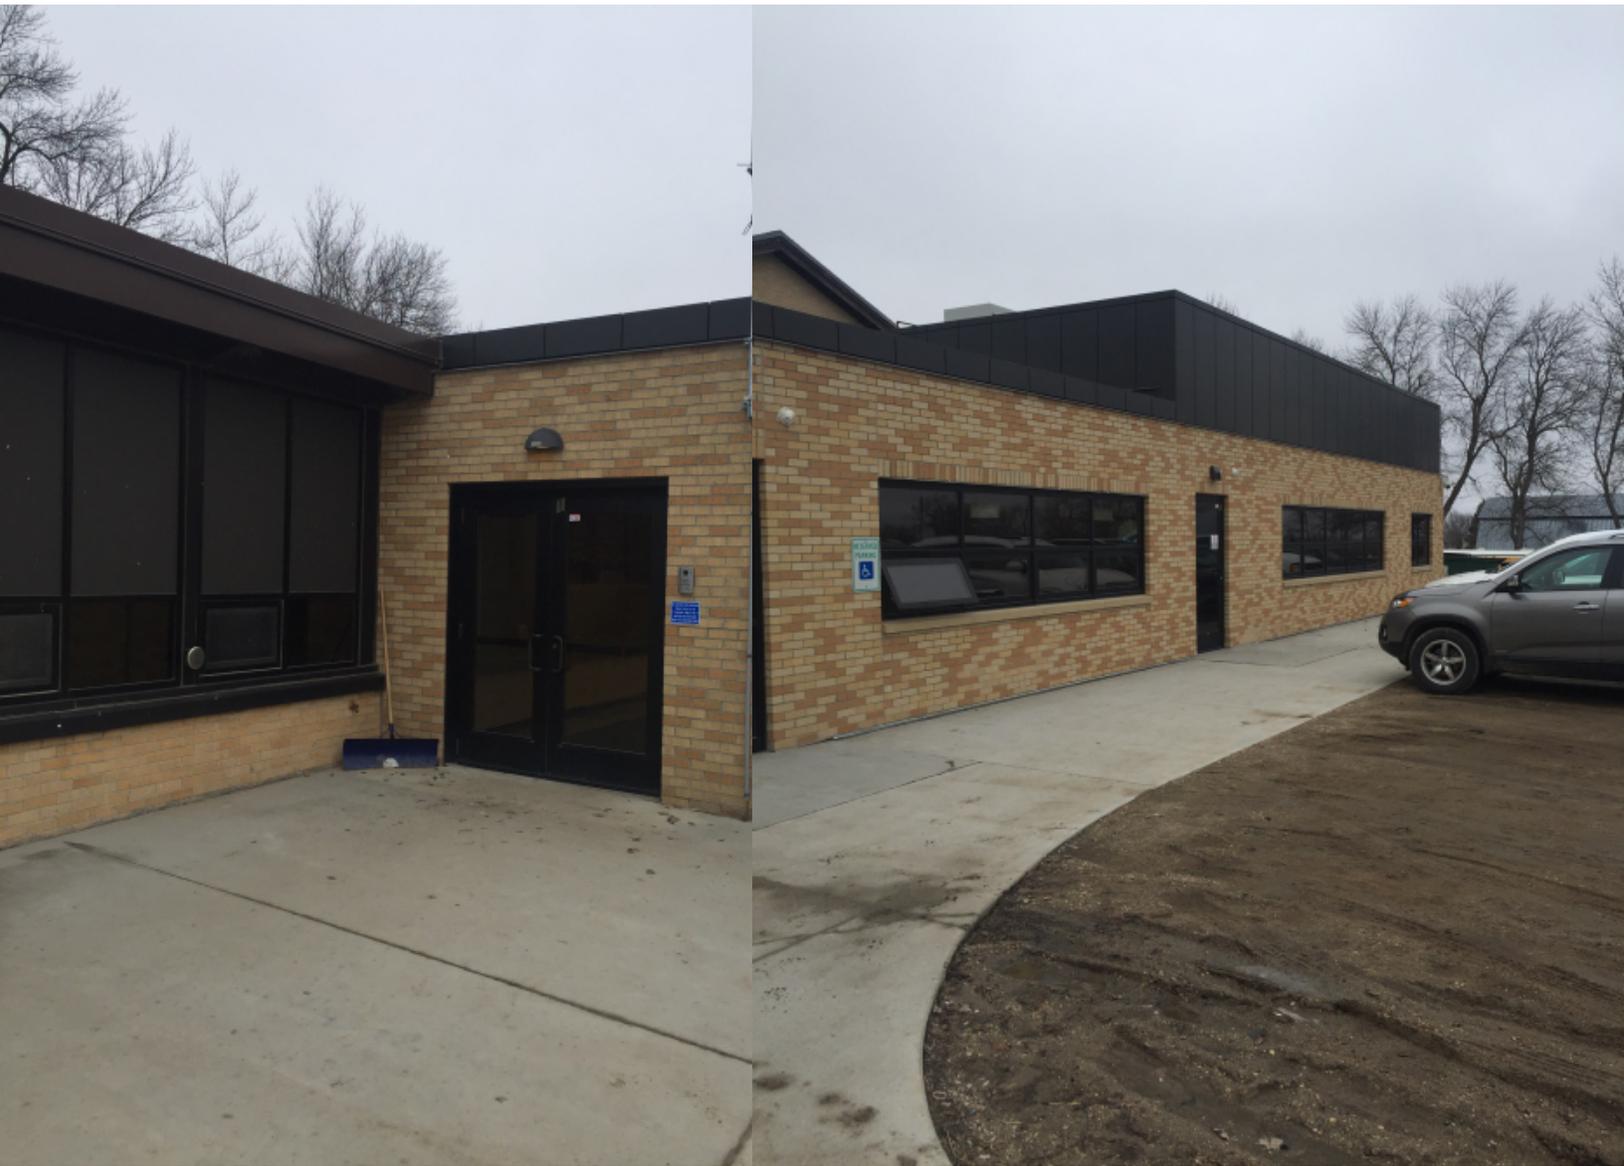
2012 IBC: SECTION 1104.1 SITE ARRIVAL POINTS

- Accessible routes within the site shall be provided from public transportation stops; accessible parking; accessible passenger loading zones; and public streets or sidewalks to the accessible building entrance served.

Corrective Action: Provide paved parking for designated accessible parking.

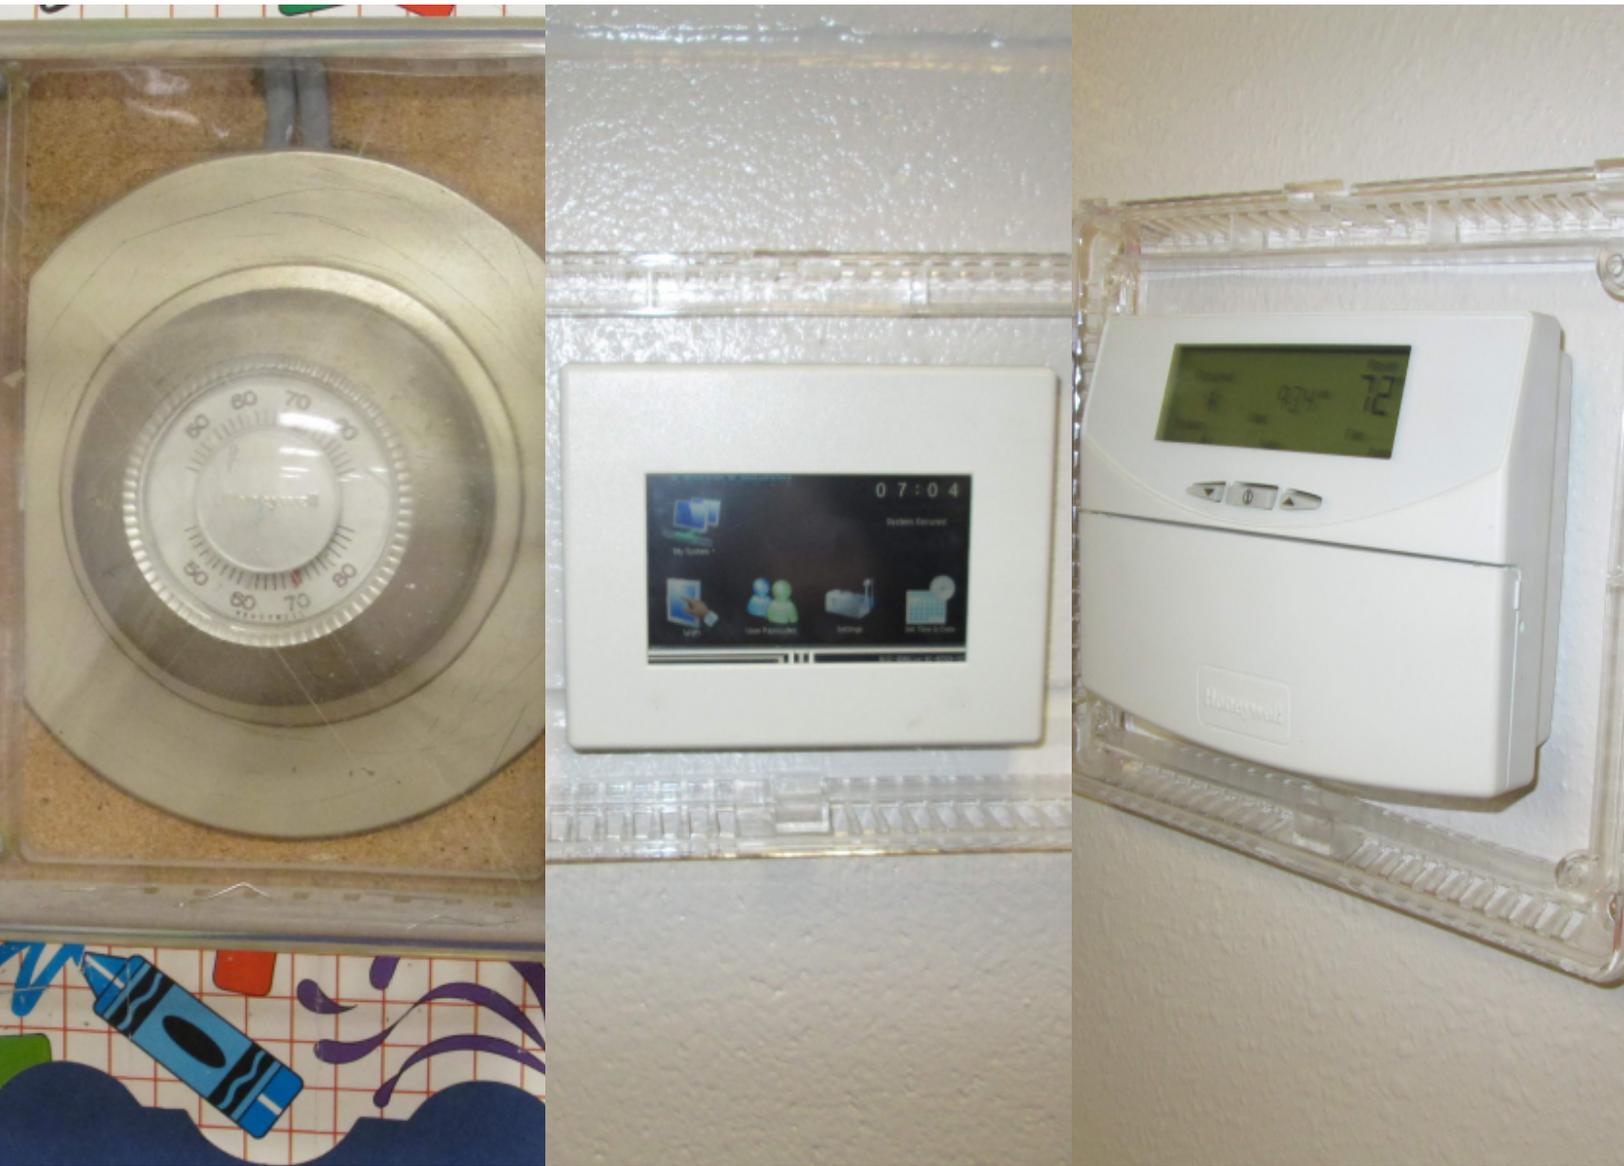
The building control system varies throughout the building ranging from standalone controls, to electric controls, to Honeywell DDC controls. Control system should be converted over to one DDC building automated control system with a user interface station throughout.

Corrective Action: The building control system varies throughout the building ranging from standalone controls, to electric controls, to Honeywell DDC controls. Control system should be converted over to one DDC building automated control system with a user interface station throughout.

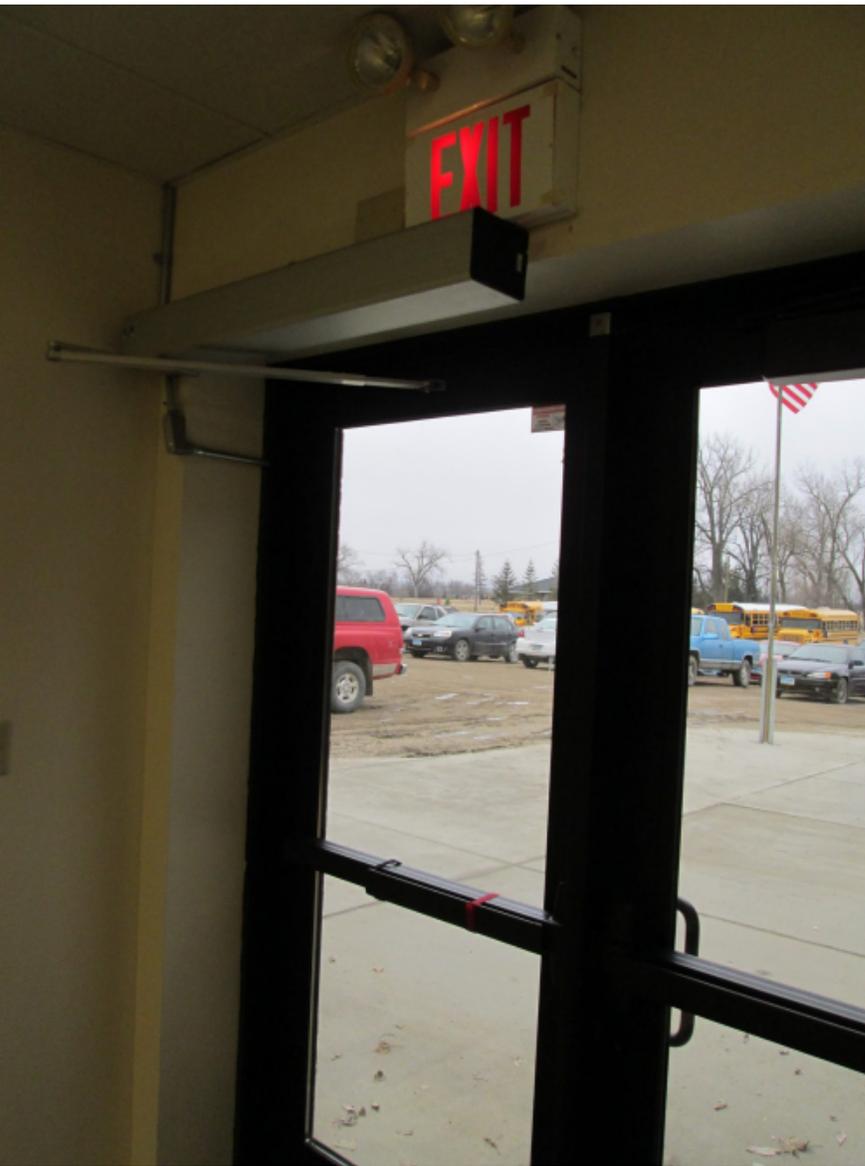
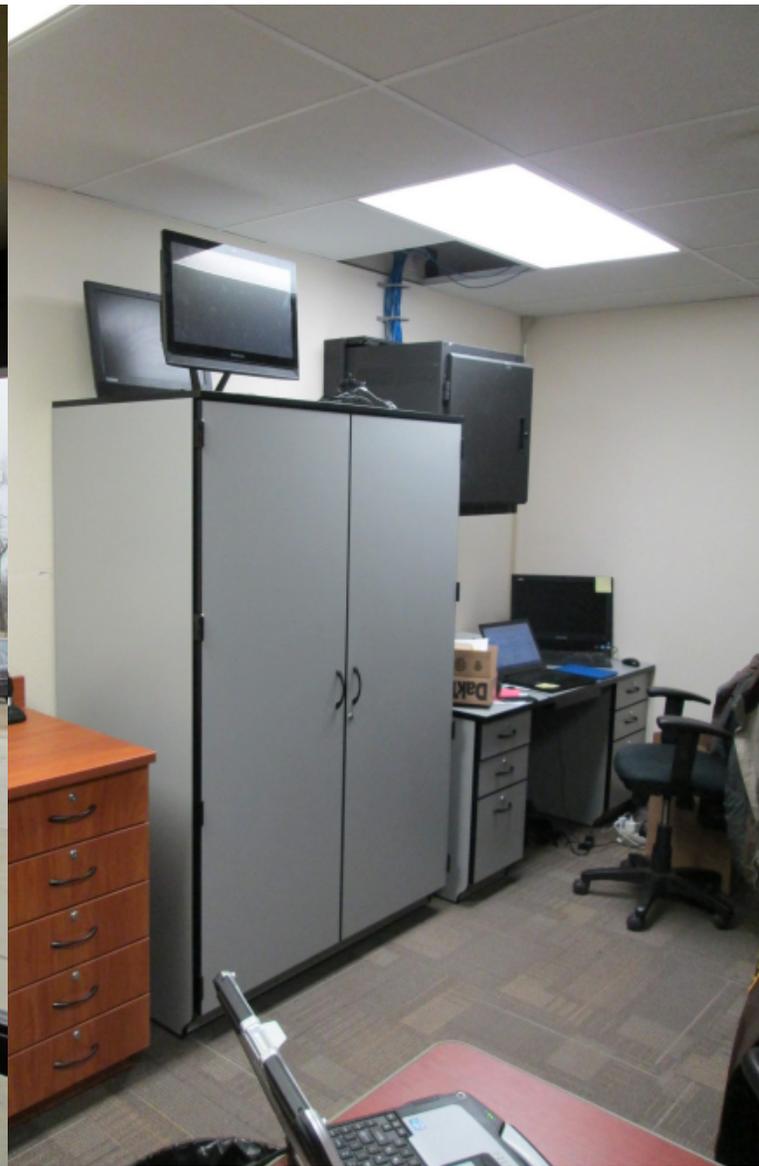
School lockdown function should be looked at to determine if there is a quicker and safer means to accomplish lockdown for the facility. Additional camera monitoring is typically required in corridors and exterior entrances for the facility.

Corrective Action: Provide school resource officer office with direct line of sight of vestibule entrance. Provide intrusion detection system for all entrances. Provide panic / alert devices in all classrooms.
